## Nottinghamshire Archives Conservation Department

### Conservation Treatment Report – 25<sup>th</sup> March 2025

#### Family Photograph

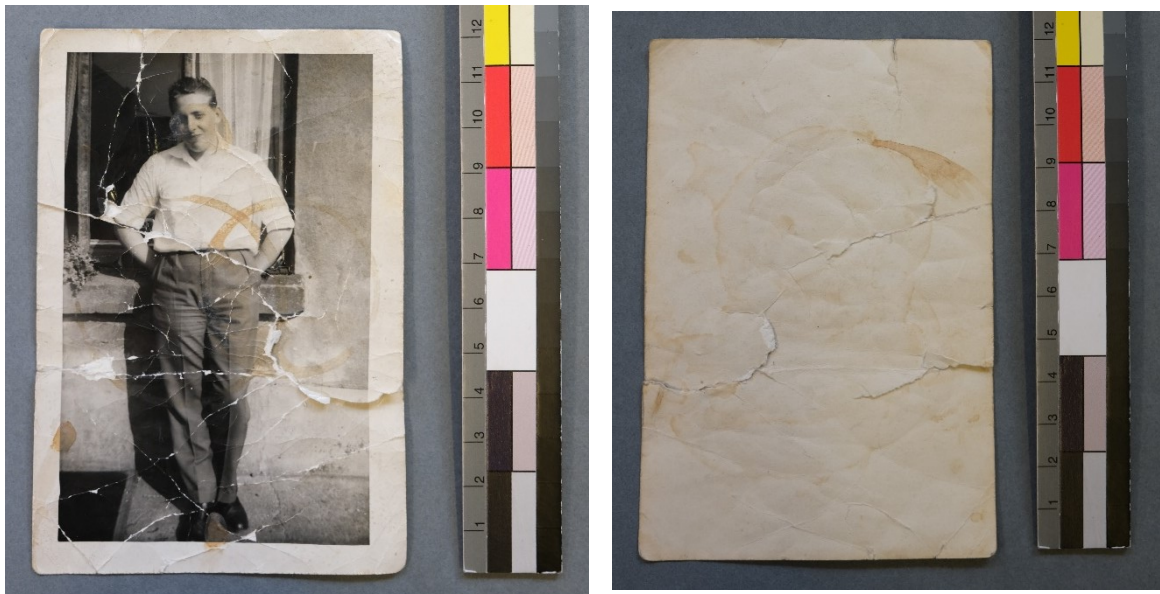
The photograph has damage to the emulsion side. Where it has been folded or creased this has made cracks in the emulsion, so the surface has a craquelure to it. Some of these lines have torn through the paper and there are losses where the emulsion layer has flaked away along the lines that have formed on the surface.

In addition, there are stains on both the recto and verso. The staining is in patches across the whole surface and there is also a general layer of surface dirt on the recto of the photograph.

*Fig. 1 & 2: Recto and verso of the photographic print before conservation.*

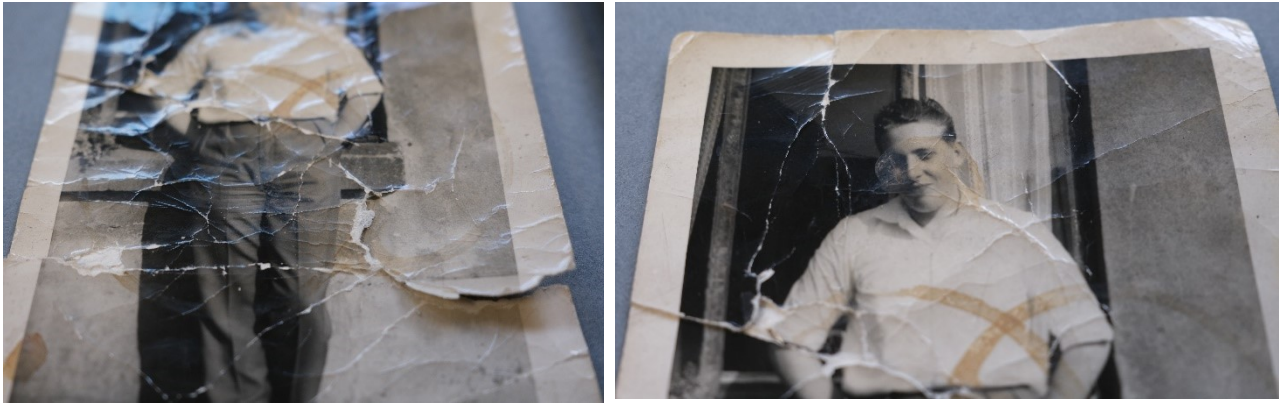
*Figs. 3 & 4: Details of the tears, craquelure surface and staining before conservation treatment.*

The tears in the photograph were repaired from the verso using Japanese tissue and purified wheat starch paste (WSP) and pressed between blotter and Bondina.

On the recto there were some losses to the emulsion and paper fibres where the print had torn, these were infilled with Japanese tissue fibres and WSP. Once dry they were toned in situ using acrylics.

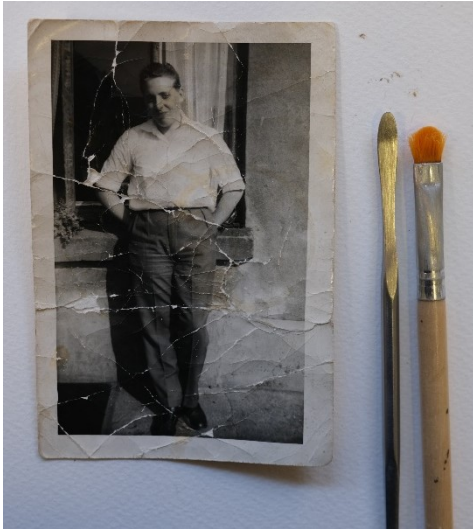
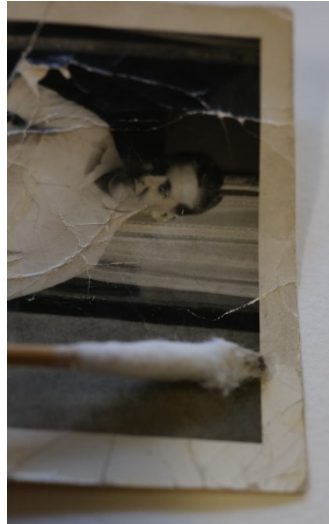
*Figs. 5 & 6: Removal of surface dirt on the print.*

The border of the print was surface cleaned with smoke sponge and the whole emulsion side of the print was brush with a soft brush to remove any surface dirt. IMS (industrial methylated spirit) and deionised water in a 50:50 mix was used on a cotton swab to remove surface dirt from the border on the recto. The same solution was used on the areas of staining after what could be removed mechanically was carried out. A soft brush and spatula were used to mechanically remove the accretions on the surface of the emulsion that were friable. The accretions looked like they were coffee and due to the duration, they have sat on the surface, some of the staining of the emulsion layer is very ingrained. Some light staining of the emulsion remains but further treatment would risk damaging the emulsion in these areas further.

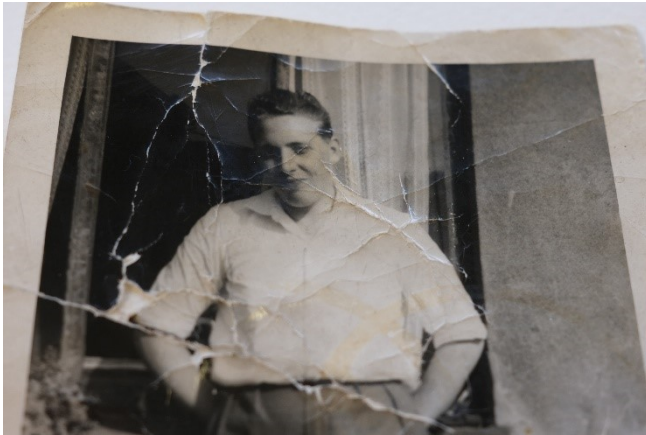
*Fig. 7: After stain removal but before infilling losses.*

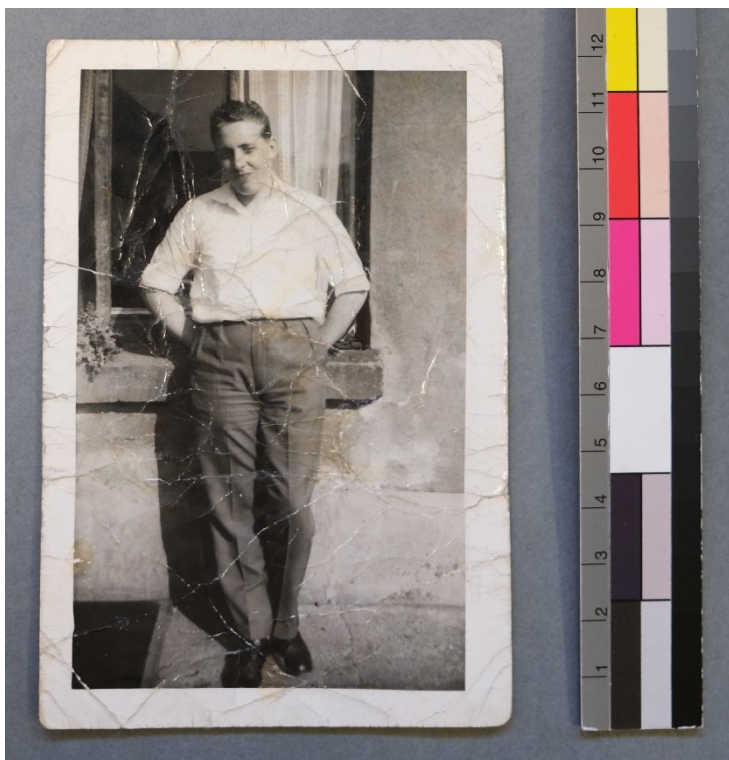
*Fig. 8: After conservation treatment.*
